general	key	notes	rev	project: Tavistock Museum	date: MARCH 23	scale: 1:50 @ A3	drawn: JN
<ul style="list-style-type: none"> <li>all drawings are copyright</li> <li>do not scale drawing</li> <li>report all discrepancies to project administrator</li> <li>all dimensions to be checked on site</li> </ul>				drawing title: <b>Existing Site photos</b>	job no: <b>1217</b>	drawing no: <b>GA-005</b>	rev: <b>T1</b>
<b>gillespie yunnie architects</b> <small>Lower Tweed Mill Shinners Bridge Dartington Devon TQ9 6JB t01803 860010 f01803 884629 e info@gyarchitects.co.uk</small>

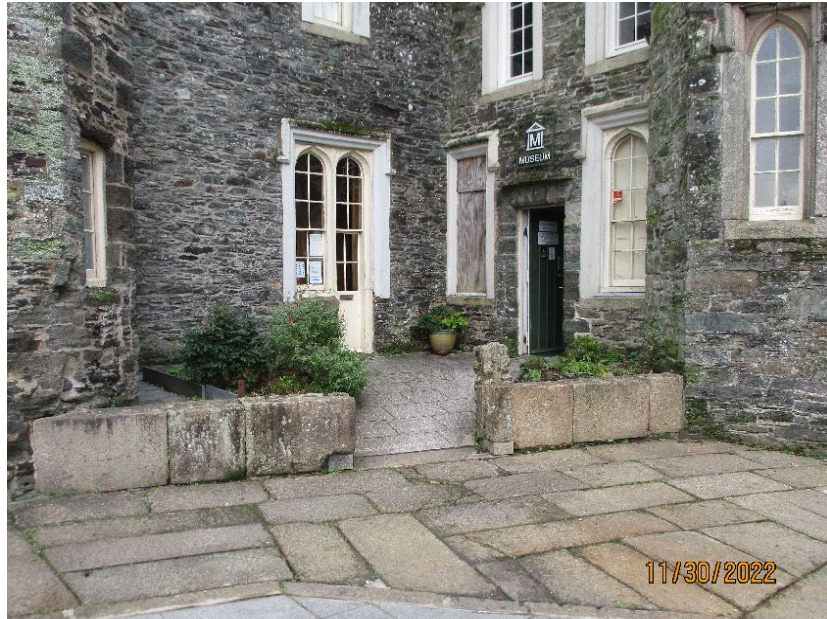
1. Museum entrance and forecourt - note access door size

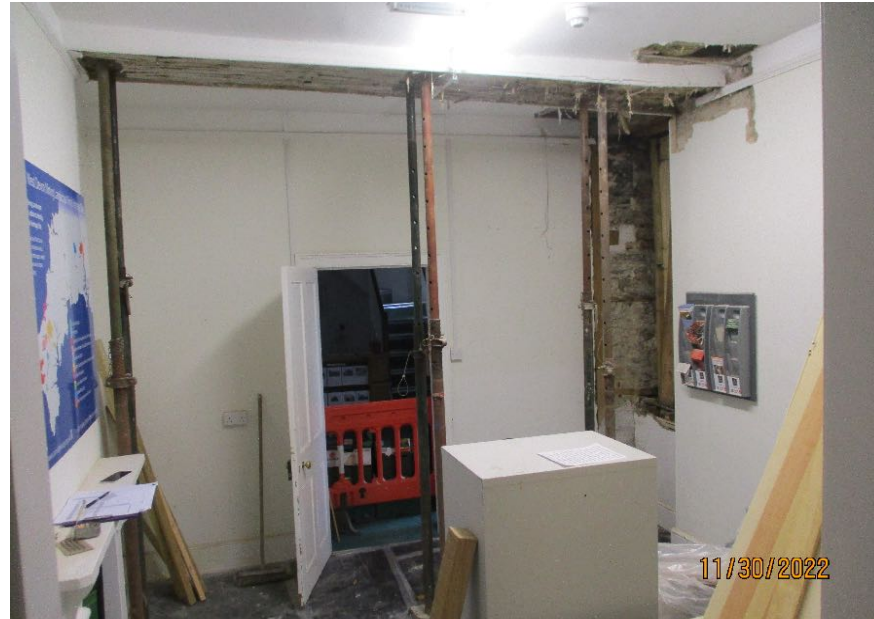
2. Ground floor -Main timber beam to be replaced - note existing timber stud wall to be removed to allow access /work space for temporary works and piling

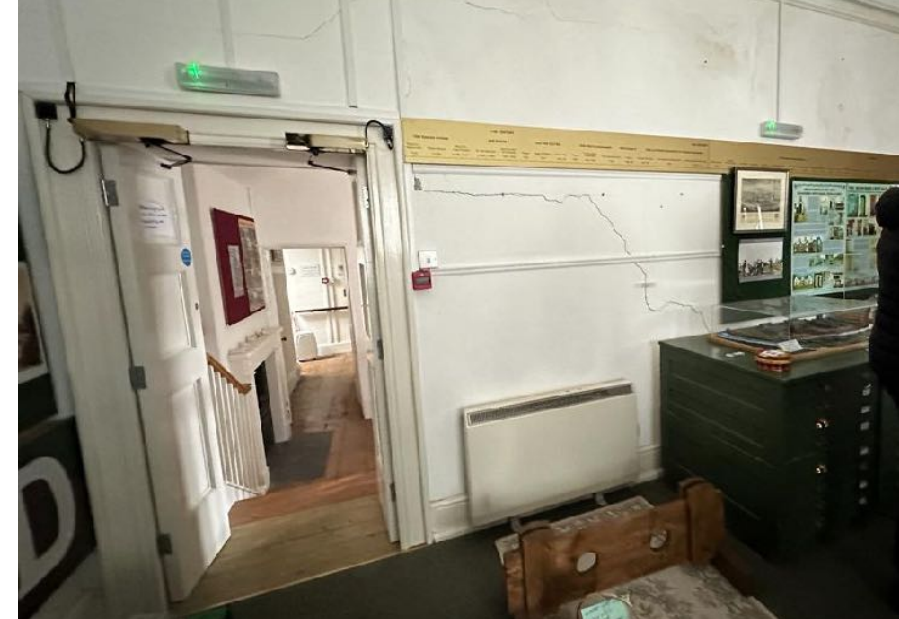
5. First floor - Existing door head supported with temporary propping and reinstated. Steps removed to allow temporary supports and reinstated

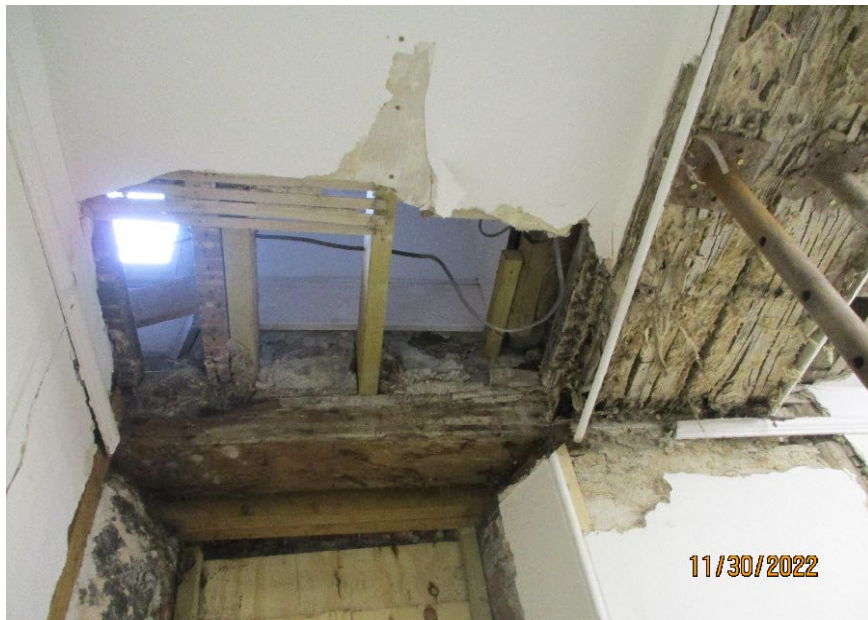
3. Ground floor - Main timber beam to be replaced and window lintel to be replaced. Affected timber to be removed and area treated for dry rot.

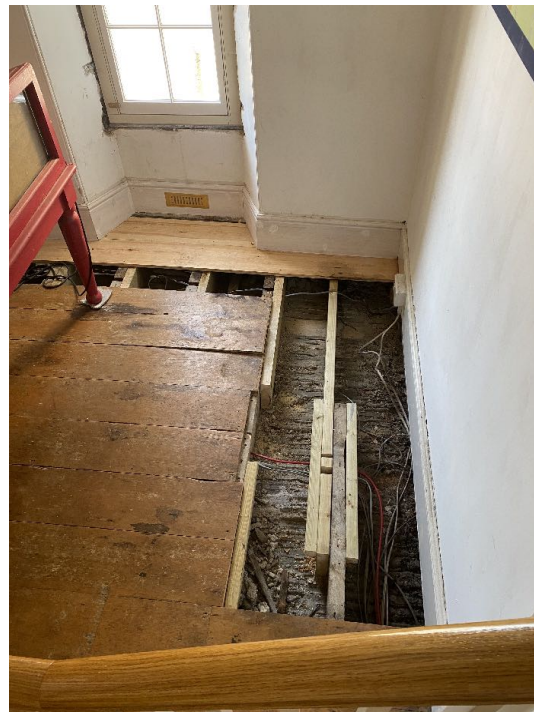
4. First floor - Existing poorly spliced joists replaced. Joist bearings resupported against external wall with new plate and hangers. Boarding made good

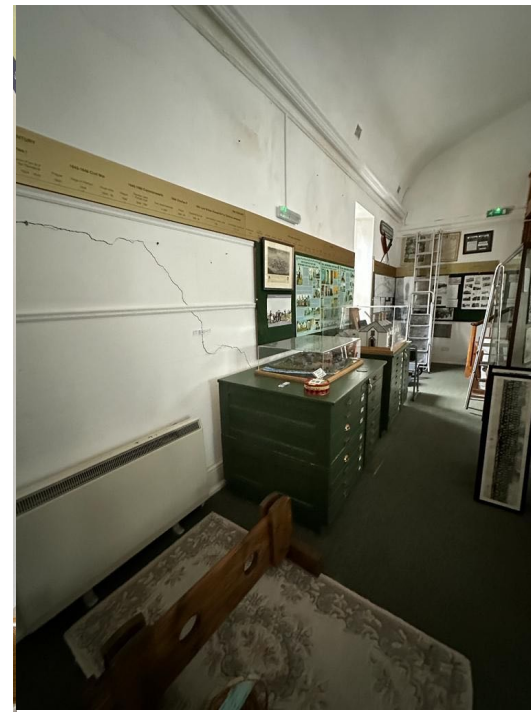
6. First floor - Cracking in primary wall above rotten beam. Wall supported with temporary works and needles while beam replaced with new steel beam. Cracking stitched
