project title: Tavistock Guildhall and Police Station	date: October 2018	scale: 1:25 @ A1 1:50 @ A3	drawn: cm
drawing title: External Window Repair Schedule 7 - East Elevation	job no: 1041	drawing no: C-361	rev: T1
gillespie yunnie architects			
Lower Tweed Mill Shimmers Bridge Dartington Devon TQ9 6JB t 01803 860010 f 01803 864929 e info@gyarchitects.co.uk

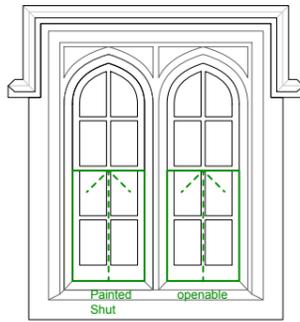
Ref: 1W17

Location: Police Station, First floor
Type Existing: Timber framed double hung single glazed sash windows
Proposed Works: Rotten cill to be replaced in new hardwood, Rake out dead and defective putties and replace in linseed oil putty, cut out swollen joints and repair using window care repair if required. Sash cords, weights, staff beads & parting beads to be refurbished where required. Window and subframe to be prepared, with painted finish.
Repair Code: Code: 2
Glazing: Not required

Subframe/ surround: To all granite mullions and window surrounds, strip back all paintwork.
Ironmongery: to be refurbished and/ or replaced where required.
Finish: Paint windows with 2no. undercoats and finish with 1no. gloss finishing coat
 Colour: White - TBC
 External M60/123
 Internal M60/150
Spec Reference: L10/210
Comments:
 - **Option A:** No Draught Seals
 - **Option B:** Draught Seal - weatherstrip around perimeter of sashes / recessed brush seal to sash meeting rail.

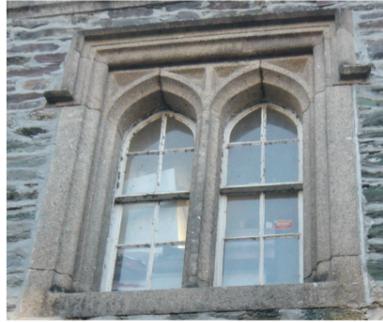
Ref: 1W18

Location: Police Station, First floor
Type Existing: Timber framed double hung single glazed sash windows
Proposed Works: Rotten cill to be replaced in new hardwood, Rake out dead and defective putties and replace in linseed oil putty, cut out swollen joints and repair using window care repair if required. Sash cords, weights, staff beads & parting beads to be refurbished where required. Window and subframe to be prepared, with painted finish.
Repair Code: Code: 2
Glazing: Not required

Subframe/ surround: To all granite mullions and window surrounds, strip back all paintwork.
Ironmongery: to be refurbished and/ or replaced where required.
Finish: Paint windows with 2no. undercoats and finish with 1no. gloss finishing coat
 Colour: White - TBC
 External M60/123
 Internal M60/150
Spec Reference: L10/210
Comments:
 - **Option A:** No Draught Seals
 - **Option B:** Draught Seal - weatherstrip around perimeter of sashes / recessed brush seal to sash meeting rail.

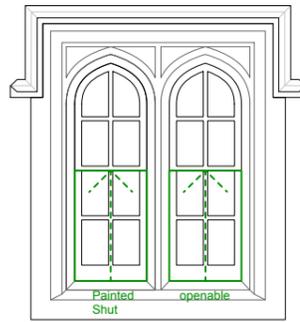
Ref: GW15

Location: Police Station, Ground floor
Type Existing: Timber framed single glazed fixed windows
Proposed Works: Rotten cill to be replaced in new hardwood, Rake out dead and defective putties and replace in linseed oil putty, cut out swollen joints and repair using window care repair if required. Existing extraction fan to be removed and replaced with glass. Window and 2no. panes of glass reinstated, with painted finish. External vertical metal bars to be removed, any damaged surrounds to be made good.
Repair Code: Code: 2
Glazing: *Single clear float glass to match existing windows

Subframe/ surround: To all granite mullions and window surrounds, strip back all paintwork.
Ironmongery: to be refurbished and/ or replaced where required.
Finish: Paint windows with 2no. undercoats and finish with 1no. gloss finishing coat
 Colour: White - TBC
 External M60/123
 Internal M60/150
Spec Reference: L10/210
Comments: Power cable penetrating through window. Further investigation required before removal.

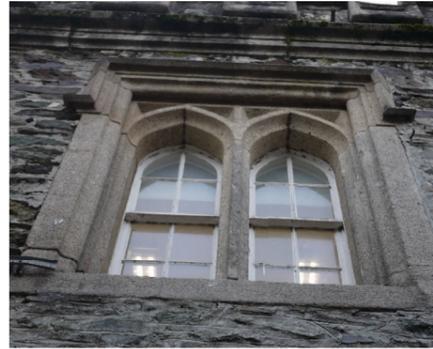
Ref: GW16

Location: Police Station, Ground floor
Type Existing: Timber framed side hung single glazed casement windows
Proposed Works: Rotten cill to be replaced in new hardwood, Rake out dead and defective putties and replace in linseed oil putty, cut out swollen joints and repair using window care repair if required. Sash cords, weights, staff beads & parting beads to be refurbished where required. Window and subframe to be prepared, with painted finish.
Repair Code: Code: 2
Glazing: Not required

Subframe/ surround: To all granite mullions and window surrounds, strip back all paintwork.
Ironmongery: to be refurbished and/ or replaced where required.
Finish: Paint windows with 2no. undercoats and finish with 1no. gloss finishing coat
 Colour: White - TBC
 External M60/123
 Internal M60/150
Spec Reference: L10/210
Comments: Reinstate two opening sashes.
 - **Option A:** No Draught Seals
 - **Option B:** Draught Seal - weatherstrip around perimeter of sashes
